AG-AVT-140

Corrosion Fatigue and Environmentally Assisted Cracking in Aging Military Vehicles

Published March 2011

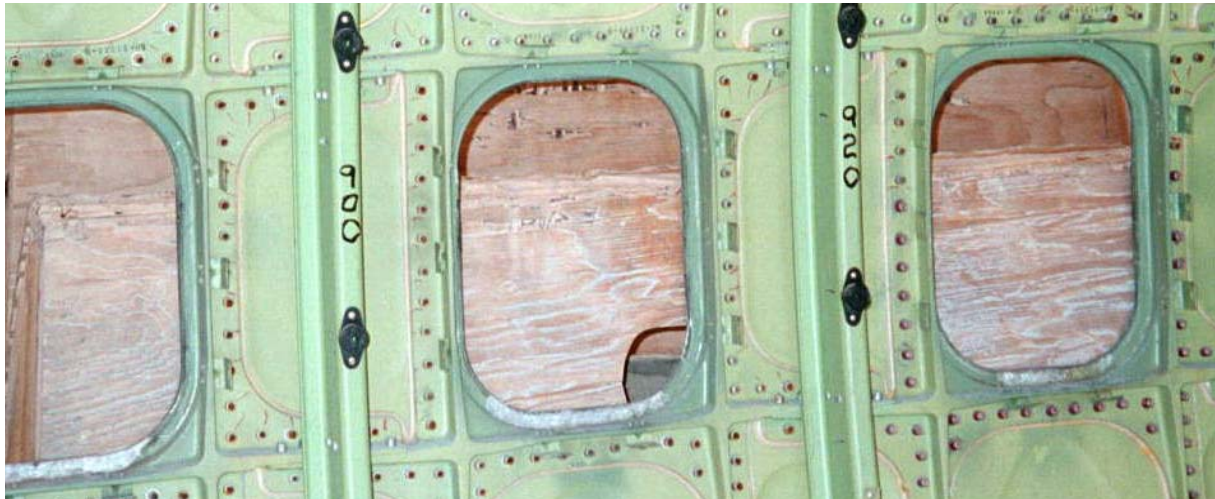
Figure 27-44: Lower Window Frame Corrosion Due to Moisture Accumulating Between Seal and Structure of Stored Airframe.

Note from Figure 27-42 that these WFU aircraft are parked in desert environments. Actually, deserts are *not* the best places to store aircraft that have been in service. It has been assumed that the arid climate minimizes corrosion activity. This may be true for the exterior surfaces, but experience has shown that the closed-off internal environments still support corrosion processes, and the high daytime temperatures may well accelerate them. Consequently, desert storage areas have proven to be productive sources of examples of service and post-service corrosion, Figure 27-43 and Figure 27-44.
